QUALITÀ DEGLI HABITAT FLUVIALI

Tratto di monte

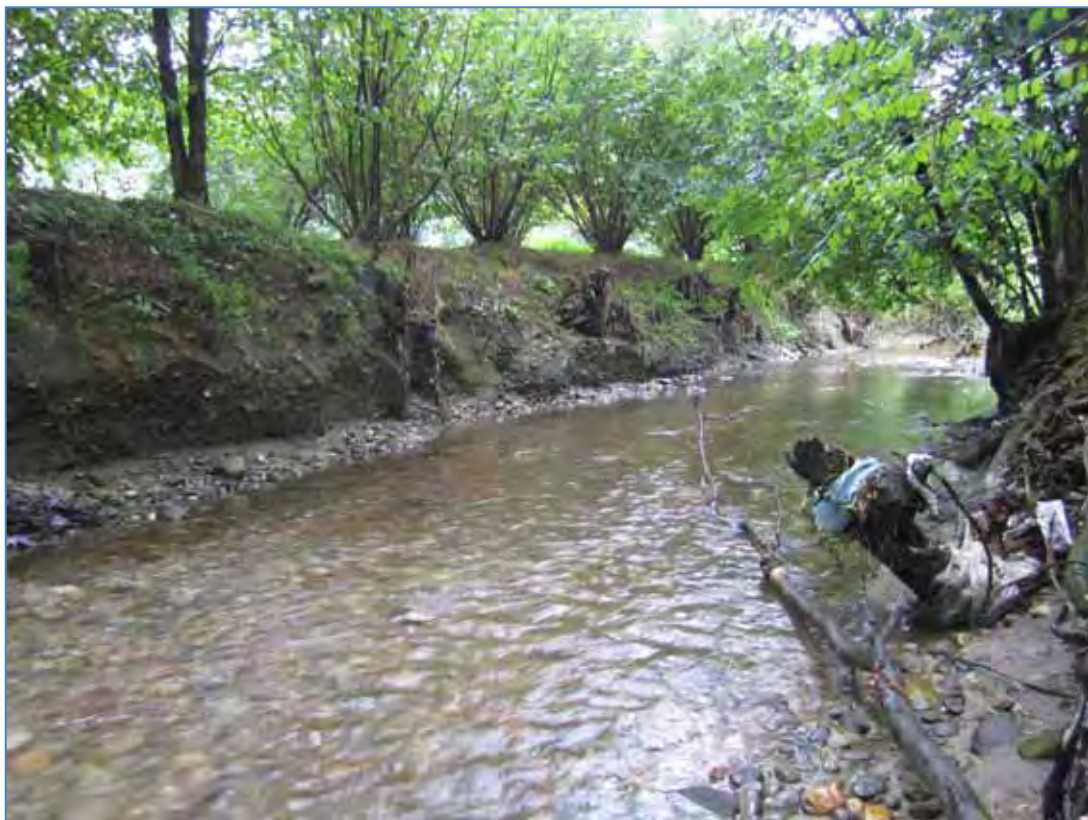
In estrema sintesi, a generare lo scadimento al Sufficiente dell'indice HMS nel tratto di monte concorre principalmente il risezionamento delle sponde legato all'attività agricola circostante, che in questo tratto affligge omogeneamente tutti i 500 metri presi in esame, mentre nel tratto di valle è presente ma con delle eccezioni, che consentono al giudizio finale di rimanere nella classe "Buono".

Sponde del torrente risezionate

verticale delle sponde, sia la variabilità dei mesohabitat lotici, attualmente molto sbilanciati verso la pozza, saranno oggetto, durante il progetto di realizzazione delle vasche di laminazione, di specifici interventi nel tratto di valle, che potranno portare a miglioramenti significativi sullo stato degli habitat fisici del Lura.

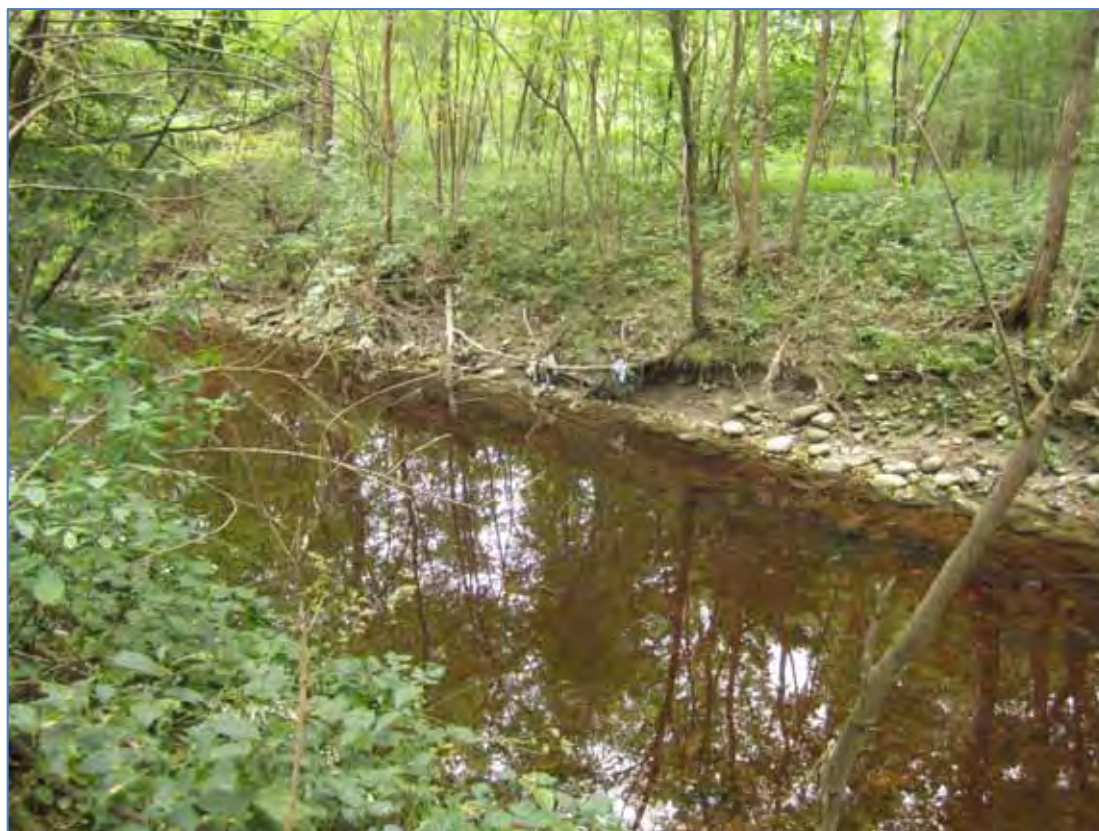
di valle la maggior presenza di bosco (per quanto si tratti di un bosco composto essenzialmente da robinia) permette di mantenere maggiore naturalità. Il ultimo, il valore di HQA ottenuto in entrambi i tratti è superiore al limite tra l'Elevato ed il Buono, ma per il tratto di valle si tratta di un valore prossimo alla soglia.

Aree boscate nel territorio circostante il tratto di valle

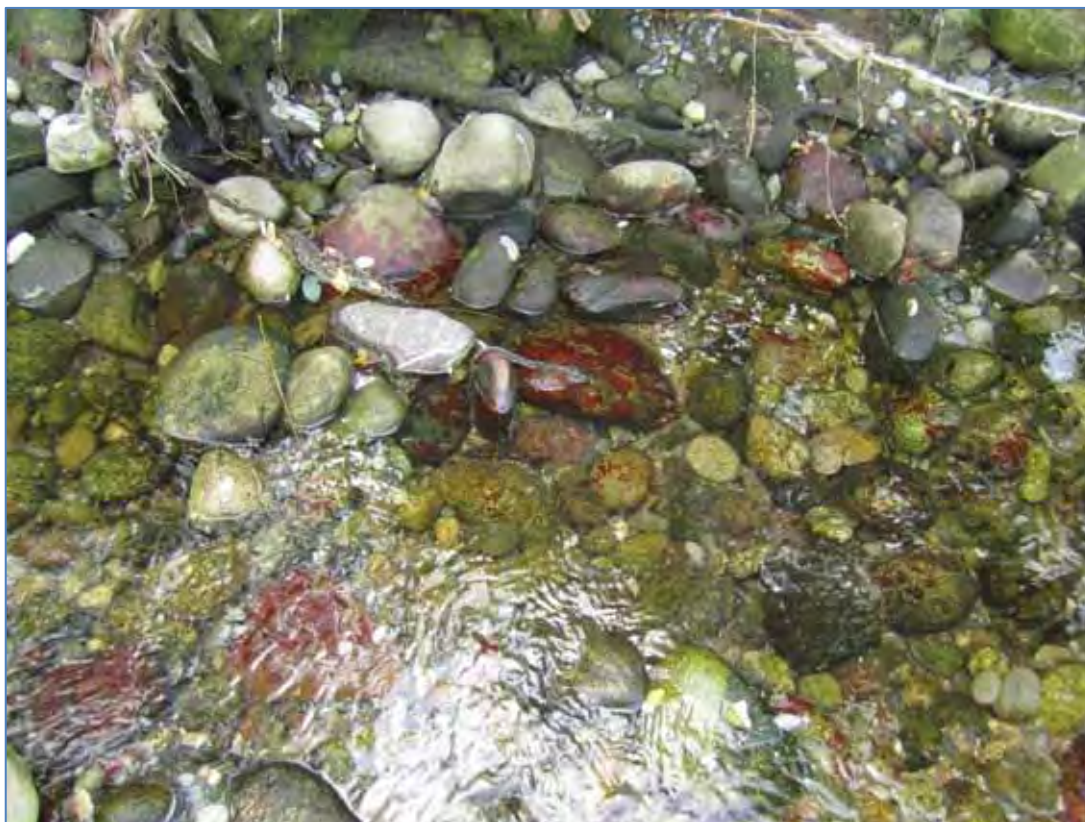
Substrato ciottoloso tipico del Lura nell'area di applicazione del CARAVAGGIO
